Inspection Report

PROPERTY INSPECTION REPORT

Concerning: , Cuero, TX 77954

By: James Barrie 23835 / Barrie Inspections & Consulting 3/4/2020

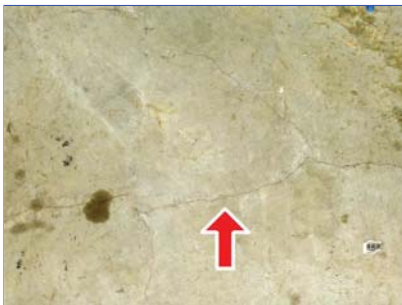
- Cracks, commonly known as curing cracks or shrinkage cracks, were observed in the garage. These cracks are commonly observed and typically do not indicate a significant defect.

A. Item 1(Picture) curing cracking (garage)

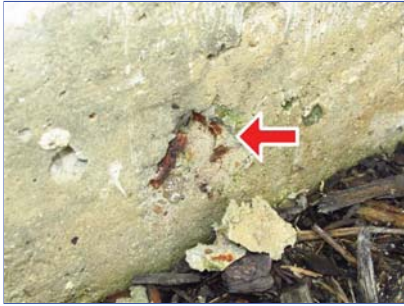
- Spalling with exposed reinforcement bar was observed. Exposed reinforcement bar should be mortared over to prevent further corrosion.

A. Item 2(Picture) exposed rebar (front flower bed)

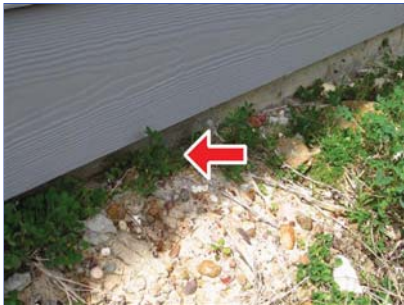
- High soil levels/flower/planting beds were observed at the foundation walls in various locations. A minimum of four inches of foundation wall should be exposed under the brick veneer and a minimum of six inches of foundation wall should be exposed under the wood surfaces. High soil levels are conducive to wood destroying insect infestation, and possible water penetration into the home. When repaired, the grade should slope downward away from the home directing runoff away from the foundation. Improvements should be undertaken by professional landscaper.

B. Item 1(Picture) high grade

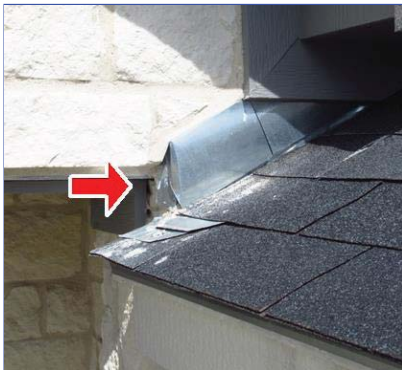
- The roof covering was observed to be in good overall condition. Condition requiring only minor repair were observed.
 1. Kick out flashing missing (near front door)
 2. Ridge vents have a slight 'saddle' shape, which could allow moisture to seep under shingles and into attic space. Recommend consulting roofer for repairs if necessary.

C. Item 3(Picture) missing kick out flashing

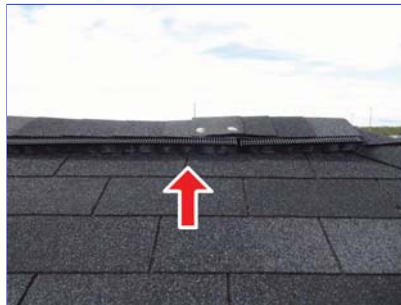
C. Item 4(Picture) ridge vent design

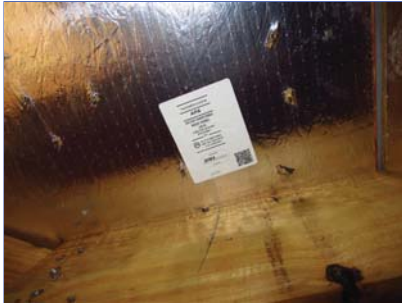
- A spray on or sheet/foil type silver "radiant barrier" was observed at the time of inspection. This product limits the inspectors ability to inspect the framing members and sheathing, as it covers the surfaces. Certain conditions may not be identified due to limited visual access to the structure.

D. Item 1(Picture) radiant barrier

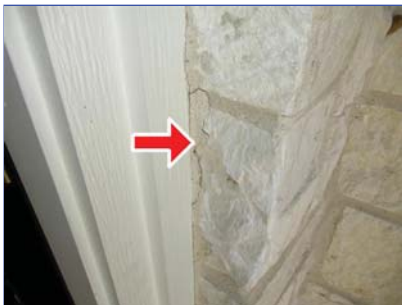
- Masonry (brick / stone) cracks were observed front of the home. Cracks of this type are common in home of this age and are typically not associated with a significant structural defect.

E. Item 1(Picture) mortar cracking

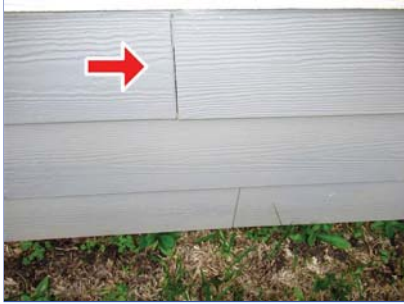
- Various areas of the exterior cement fiber board siding need caulking improvements to prevent moisture intrusion at joints.

E. Item 2(Picture) cement fiber board joint

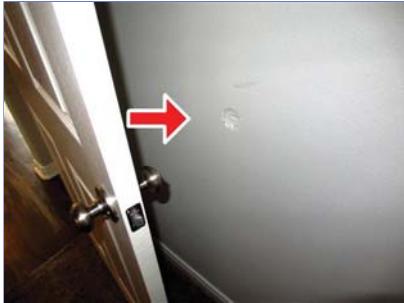
- The wall(s) master bedroom was/were observed to have the following defect(s): dented or damaged from door knob. The cracks appear to be superficial in nature. Recommend plastic door knob wall plates be installed behind doors to prevent future damage.

E. Item 3(Picture) door knob damage

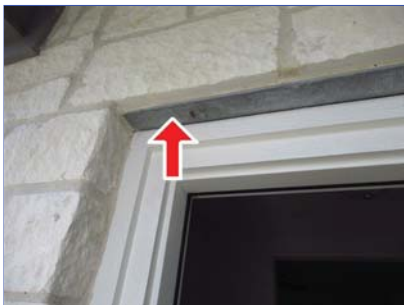
- An exposed metal lintel end(s) was observed in various locations. Exposed lintel ends should be primed with paint and covered with mortar/paint to prevent to corrosion.

E. Item 4(Picture) exposed lintels

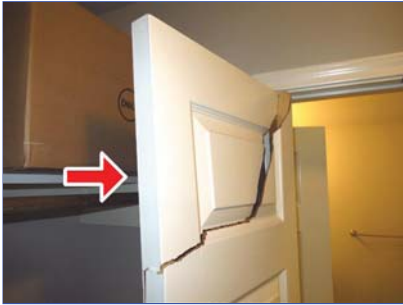
- The interior door(s) master bedroom closet was/were observed to have the following defect(s):
 1. damaged; in need of replacement

G. Item 1(Picture) broken closet door

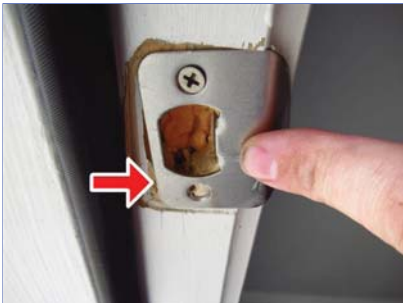
- The exterior door(s) front of home was/were observed to have the following defect(s): loose hardware. A screw is needed to repair. Recommend replacing these screws with minimum 2" screws for added security.

G. Item 2(Picture) striker missing screw

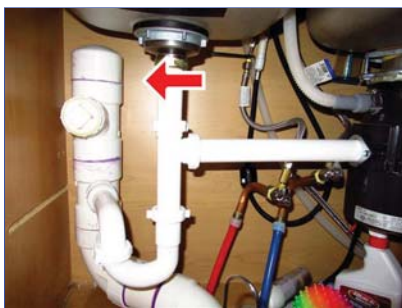
- Plumbing vent(s) for the kitchen was/were observed to not be terminated through the roof due to the location of the sink. Recommend installation of an air admittance valve (AAV) to allow proper drain venting. A licensed plumber should be consulted for any repairs needed.

B. Item 1(Picture) missing AAV

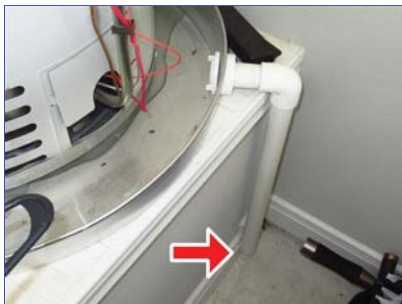
- Drain pan does not extend to exterior as required. Recommend repair to meet current standards.

C. Item 3(Picture) drains onto garage floor

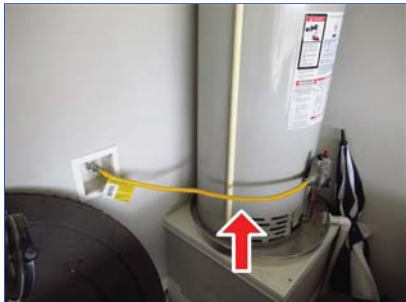
- The water heater gas supply line was observed to not be equipped with a sediment trap just before the appliance connector. This condition does not meet current installation requirements and should be corrected. A licensed, qualified plumber should be consulted regarding this condition.

C. Item 4(Picture) missing sediment trap

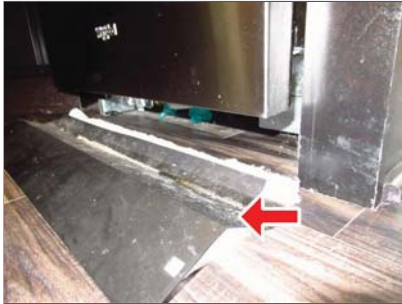
- The dishwasher was observed to have the bottom trim piece removed from the unit. This should be secured with proper length screws to the underside of the unit.

A. Item 1(Picture) bottom trim piece

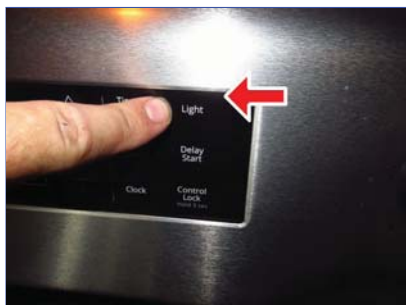
- Oven light was inoperative at the time of inspection. Recommend replacement bulb. If bulb does not repair, a repair specialist may be needed.

D. Item 1(Picture) light inoperative

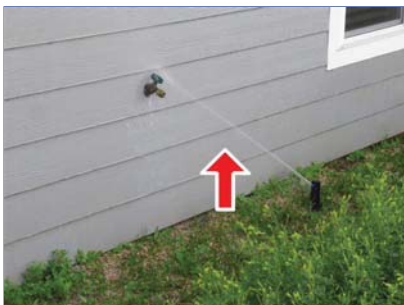
- The sprinkler heads spray excessively onto the home at the rear and sides. Long term, water damage can occur to the home. Repairs should be undertaken water from spraying onto the home.

A. Item 2(Picture) spraying directly onto home

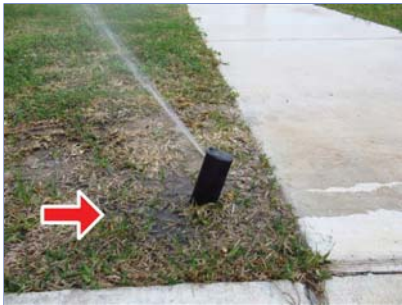
A. Item 3(Picture) tilted head / possible under ground leak

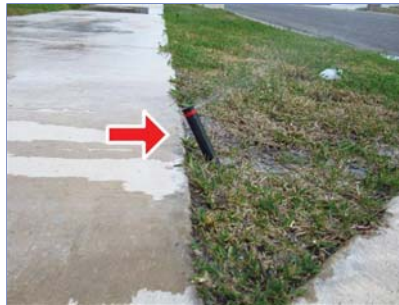
A. Item 4(Picture) not perpendicular to ground

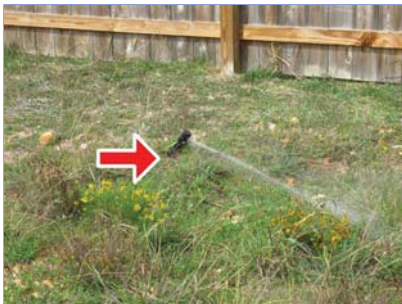
A. Item 5(Picture) spraying down

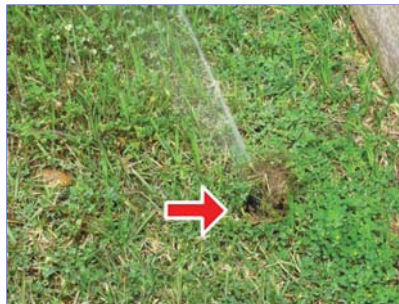
- 2. Grass over sprinkler heads should be cleared to allow proper pop-up operation
- 3. Zone 1 (right side of home near electric panels) timer needs to be set for shorter duration to prevent flooding)

A. Item 6(Picture) head could not pop-up entirely

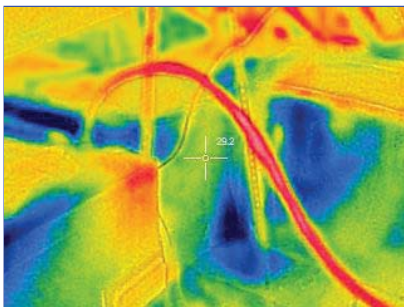
- A thermal imaging scan of the heating and air conditioning system revealed only small air leaks in the ducting.

B. Item 3(Picture) slight duct leakage (attic)

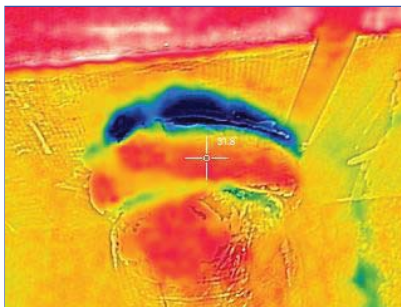
B. Item 4(Picture) flex duct leak
